BIOLOGICAL ASSESSMENT

JOSEPHINE WASH RESTORATION PROJECT

Prepared for
YAVAPAI APACHE NATION
ENVIRONMENTAL PROTECTION DEPARTMENT
2400 West Datsi Street
Camp Verde, Arizona 86322

Prepared by:
KETZEL ENVIRONMENTAL TRAINING and SERVICES LLC
Stuart (Stu) Tuttle, Owner, Manager
3391 S. Gillenwater Dr.
Flagstaff, AZ 86005
(928) 607-3302

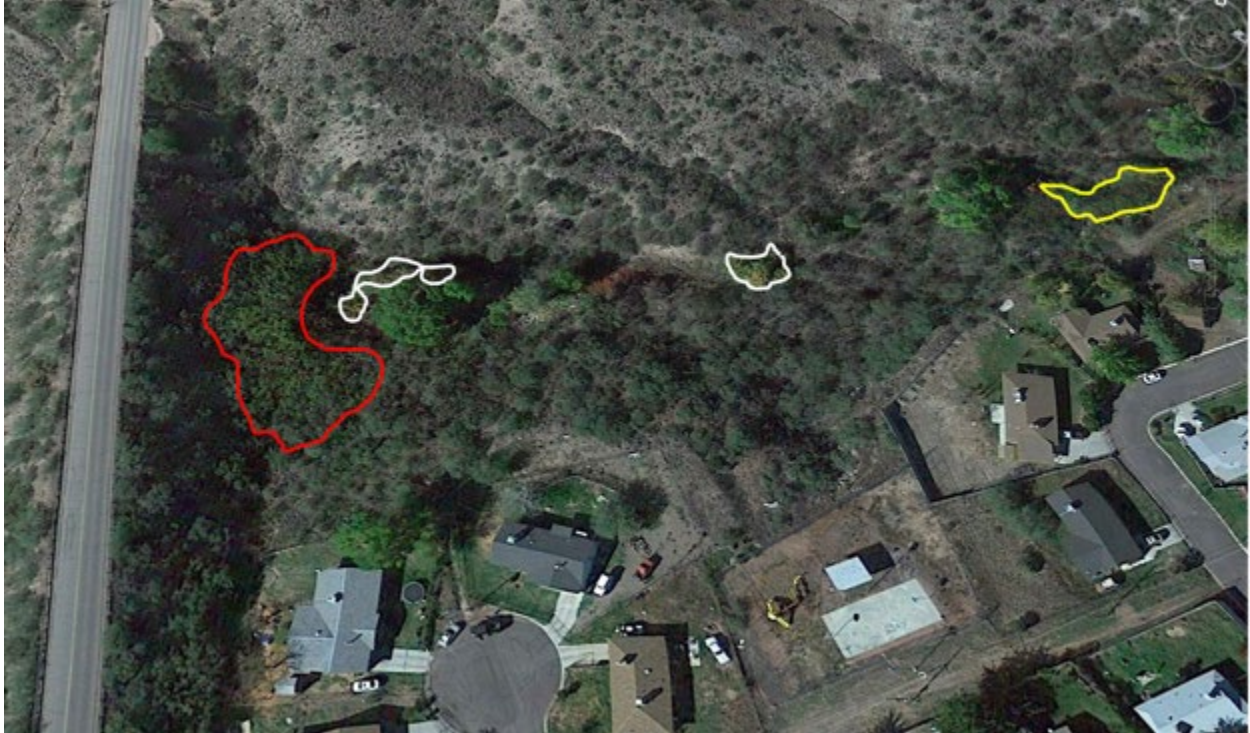
Figure 2-1. Approximately western third of Project area. White = Tamarisk removal. Yellow= Arundo removal. Red = Tree of Heaven removal.

Brush Management: The removal or control of woody (non-herbaceous or succulent) plants, primarily Salt Cedar (*Tamarix ramosissima*) and Tree of Heaven (*Ailanthus altissima*). Brush management will be applied in a manner to achieve the desired control of the target woody species and protection of desired species including spot treatment of individual plants or areas needing re-treatment due to regrowth, resprouting, or reoccurrence. This will be accomplished by hand cutting and mechanical methods, either alone or in combination. See Figures 2-1, 2-2 and 2-3 below for specific areas of treatment. Cutting and chipping of material will commence after a pedestrian survey to identify and mark active nests of migratory birds. Primary treatment will be by chainsaw, although some stumps must be removed by backhoe. A front-end loader may be used near an established roadway to transport material for chipping. Herbicide application will occur from late summer to late winter. Procedures and timing for

Herbaceous weed treatment: The removal or control of herbaceous weeds, primarily Arundo (aka Giant Reed) (*Arundo donax*), and Horehound (*Marrubium vulgare*- suspected). Arundo will be cut by hand and/or mechanically, then treated with a direct application herbicide at the base. Horehound will be treated with a spray-on herbicide from a backpack sprayer. Procedures and timing for treatment will follow NRCS guidelines found in the Field Office Technical Guide, Section IV, under 315-Herbaceous Weed Treatment: <https://efotg.sc.egov.usda.gov/#/details>.

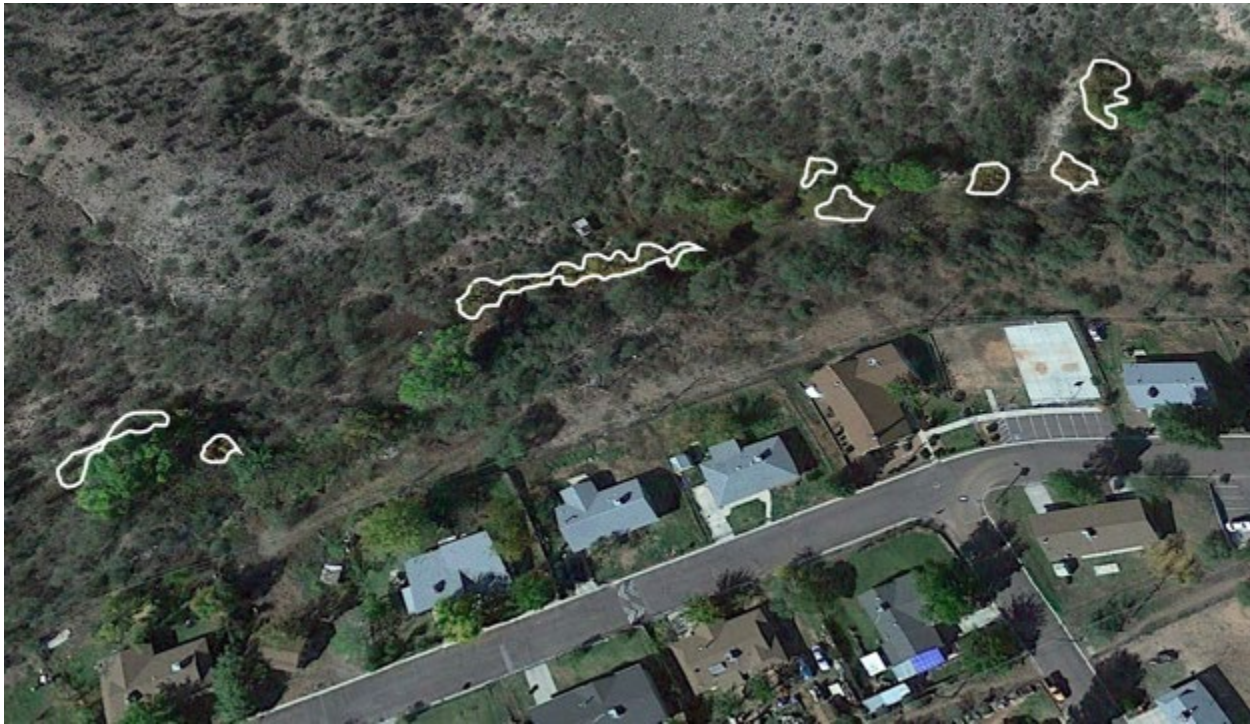
Figure 2-2. Approximately middle third of Project area. White = Tamarisk removal.

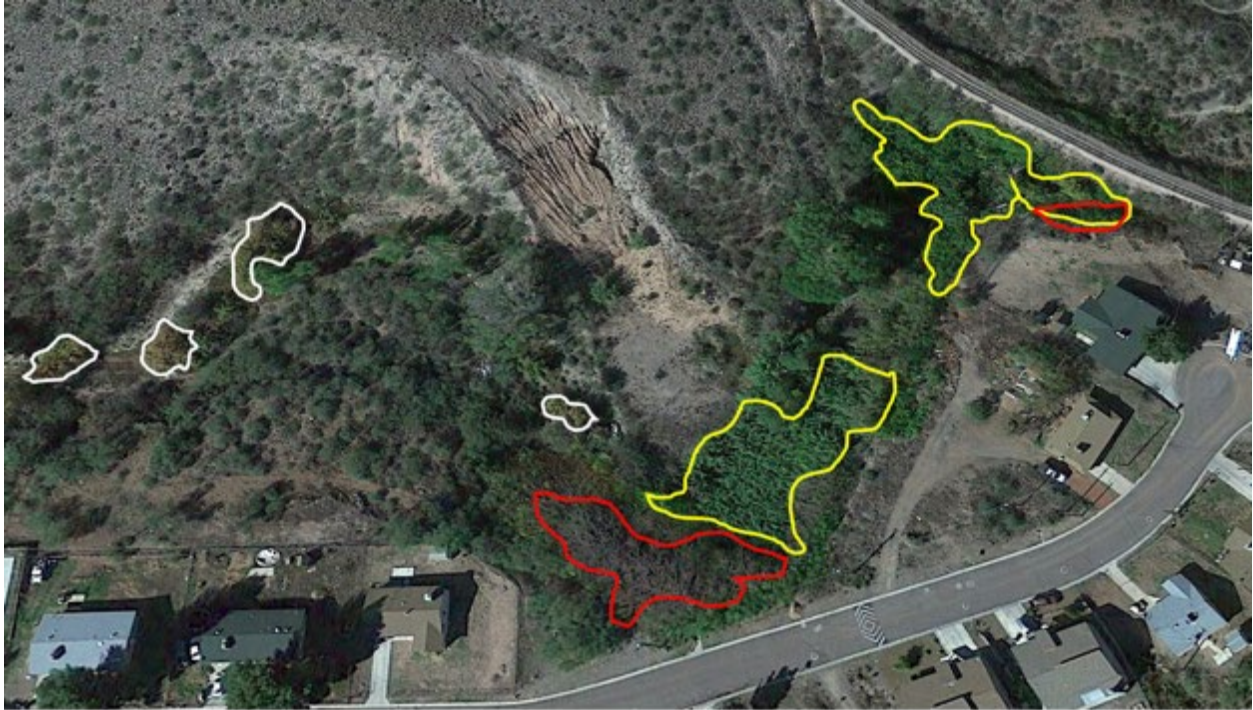
Figure 2-3. Approximately eastern third of Project area. White = Tamarisk removal. Yellow= Arundo removal. Red = Tree of Heaven removal.

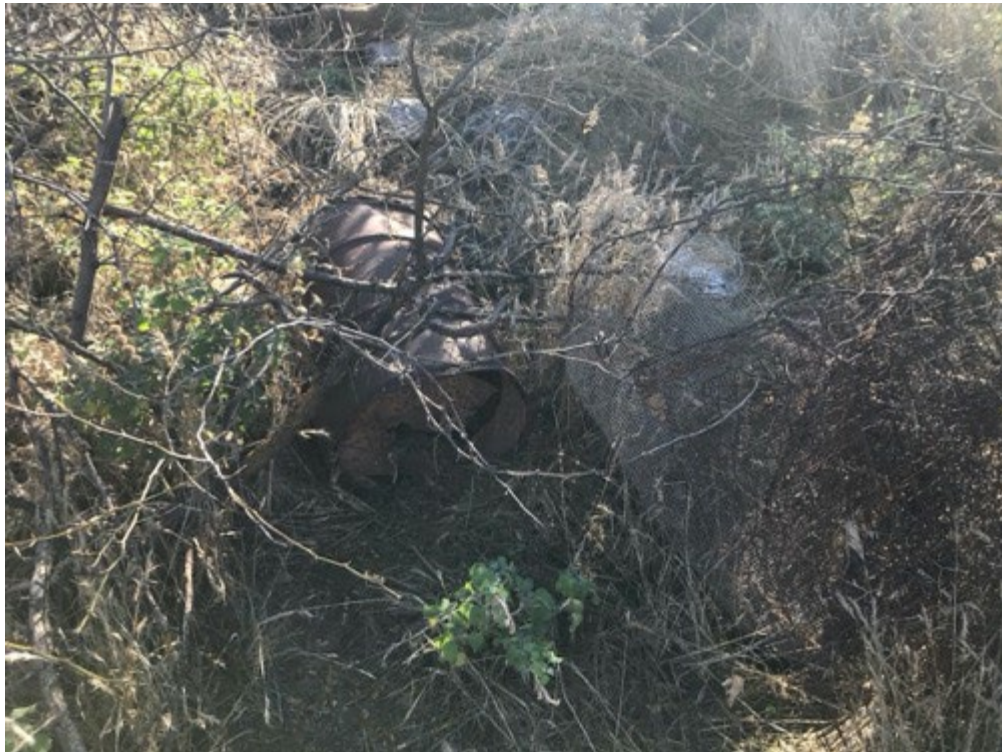
Figure 2-4. Example of trash within Project area targeted for removal during project.

Trash Removal: Trash items on the site include recent household waste such as bottle, cans, old clothing and other rubbish, but also present are older items such as washers, barrels and even an old car (Figure 2-4). As many items as possible will be collected into pickup trucks and hauled away to a designated landfill. Vehicles will remain on the two-track roadway with materials hauled to the vehicles by hand.

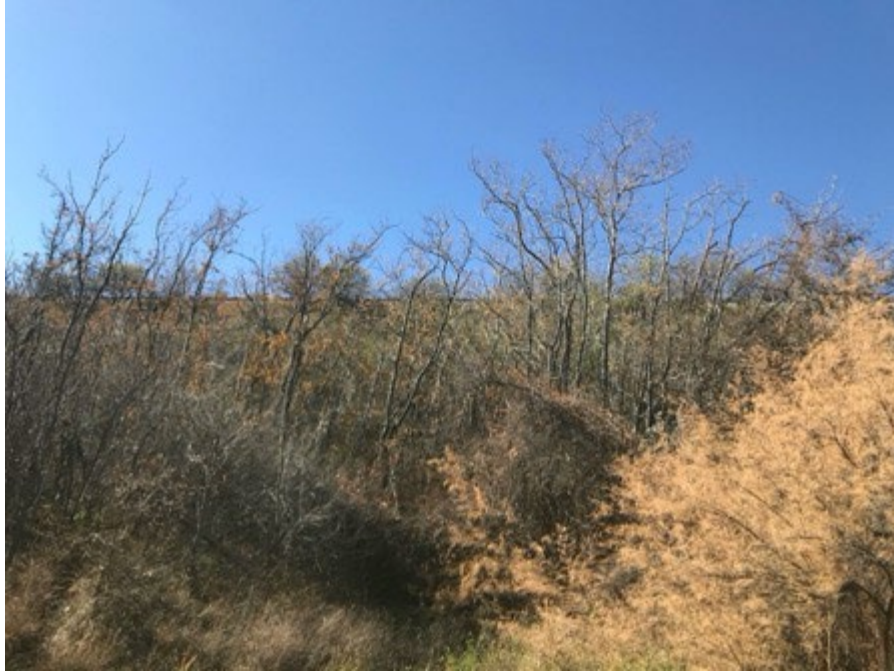
Photo 3. Looking west at embankment of Cement Plant Road. Tree of Heaven and Tamarisk targeted for removal.

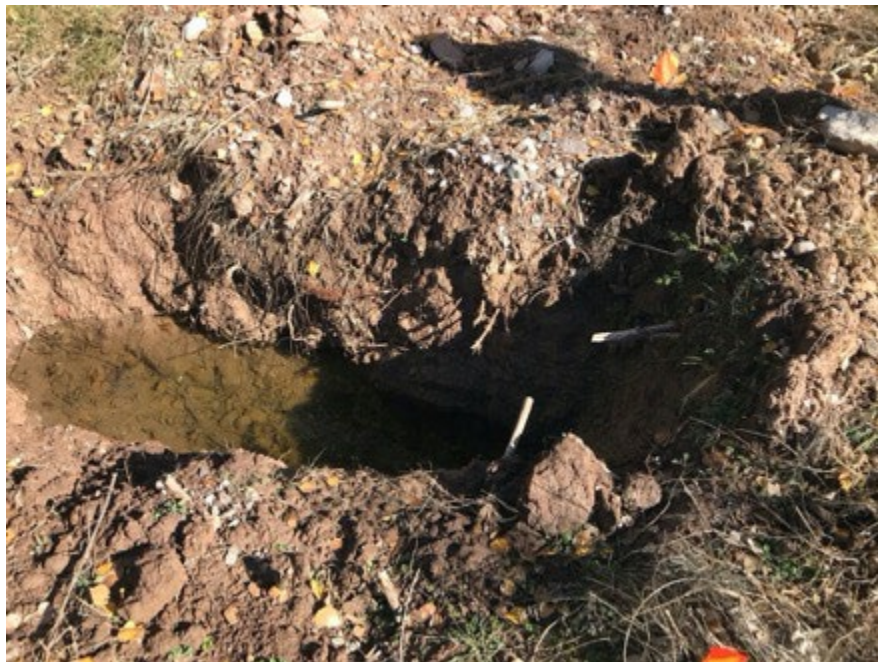
Photo 4. Hole dug in bottom of drainage near east end of Project showing ground water level.

Although the riparian zone is labeled Riverine and Freshwater Emergent wetland (Appendix 1), the channel receives substantially less water than in the past due to upstream diversion into another channel. Most of the year it remains dry except for short periods following precipitation events. The water table is also lower but is currently maintained approximately 2 feet below the lowest surface.

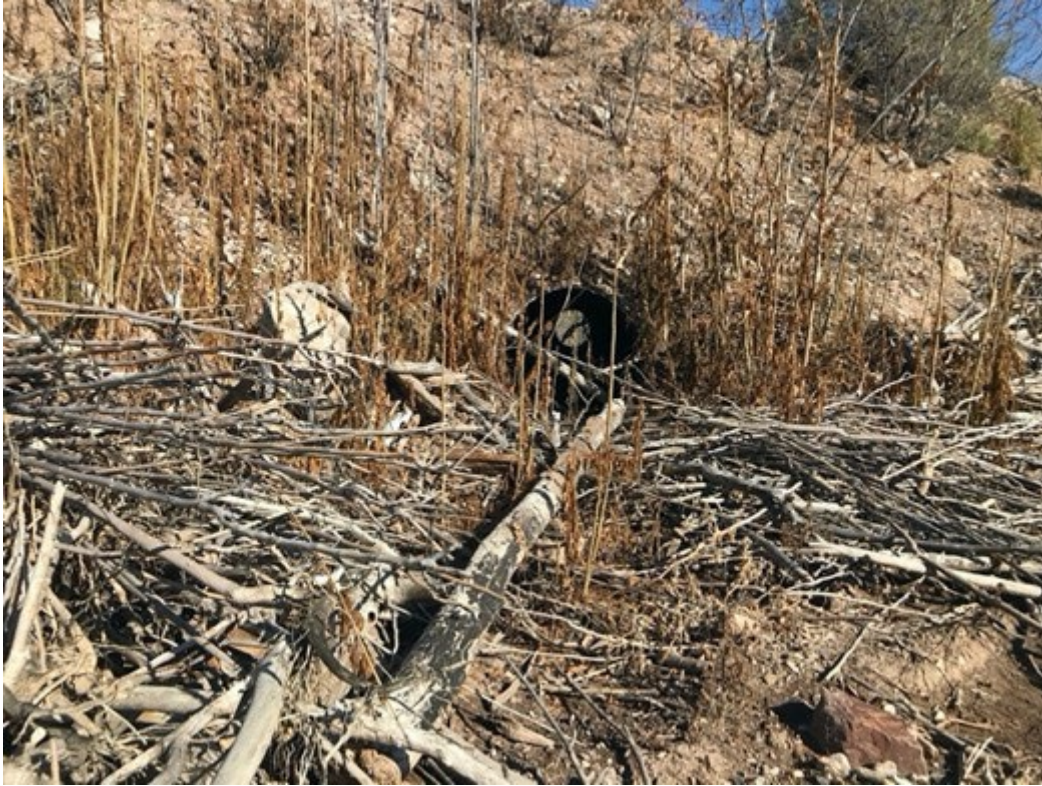
Photo 5. East end of project- terminates at entrance of culvert. Note young shoots of Tree of Heaven.
